RECALL # 20111012

PRODUCT RECALL

MLK Series Hoist, MLK-A53 Motors, ML50K-316 Shaft

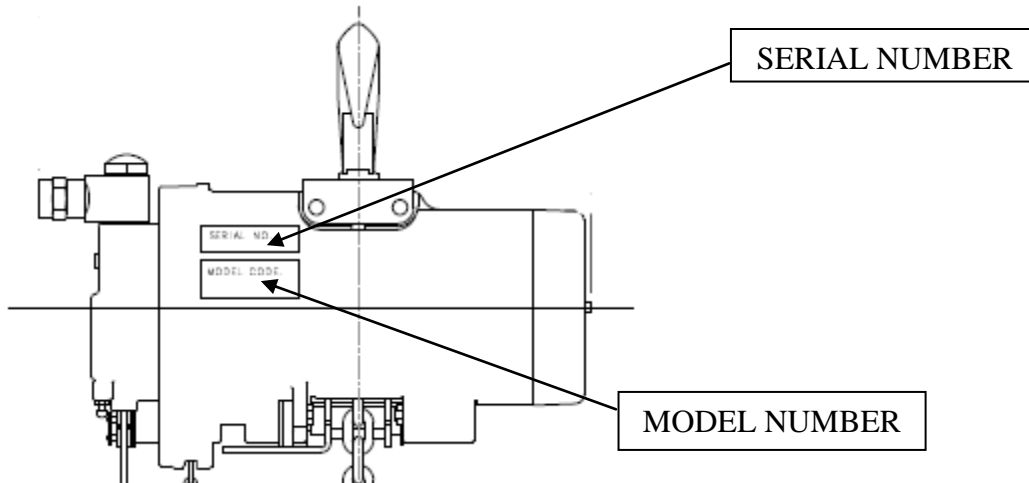
Figure 1: Location of model and serial number

MLK Series Hoists and Motors affected include the models listed in Table 1 below with the serial numbers listed above. Figure 1 shows the location of the model number and the serial number:
